Hurricane and Severe Storm Sentinel (HS3) Mission

HS3 2014-08-28 Flight Report: GLOBALHAWK AV-6 2nd Cristobal Flight

Mission goal: Second science flight into Hurricane Cristobal. Cristobal is still fairly strong, and will start its extratropical transition.

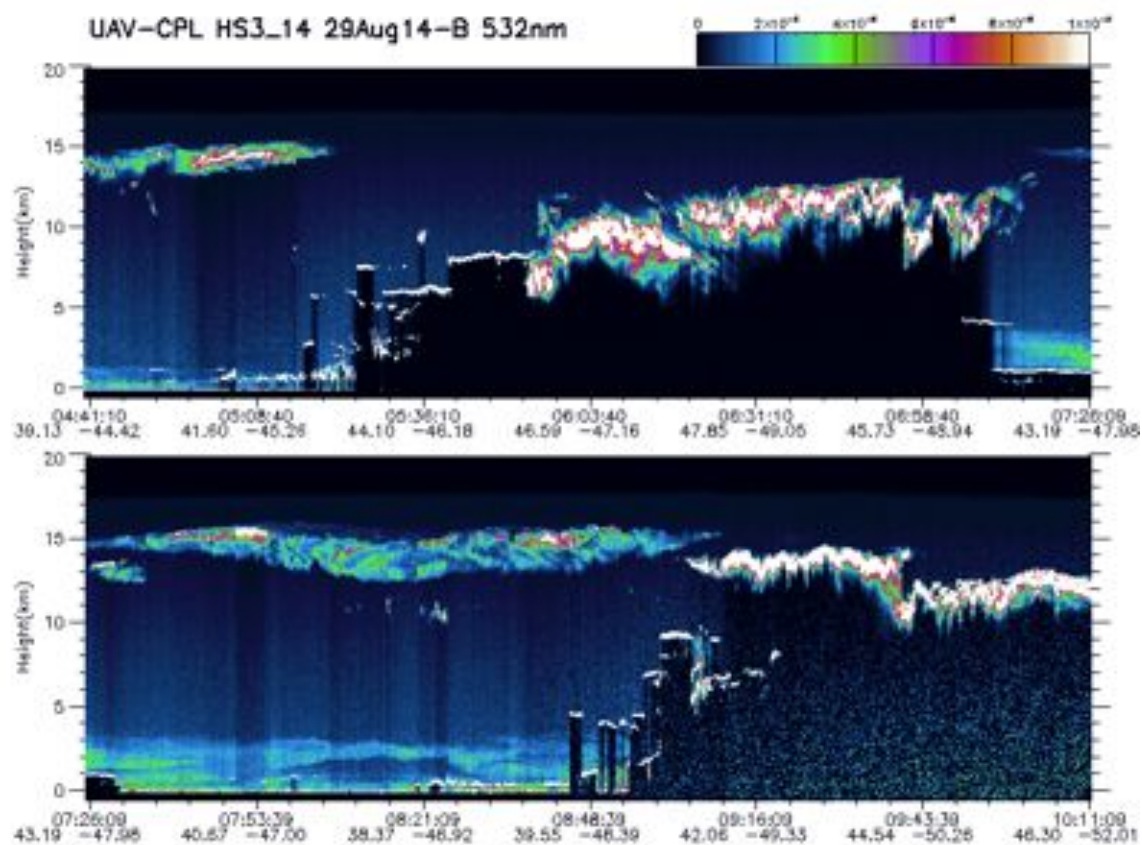
UAV-CPL HS3_14 29Aug14-B 532nm

CPL worked well for the 28-29Aug14 flight. No data issues were discovered and the instrument temperatures remained inside thresholds. CPL started data flow at 00:26:08 UTC on 29Aug. and ended data flow at 21:21:06 UTC on 29Aug. Some complex cloud/aerosol systems were overflown, with an example attached (Flight summary image for Segment B where there appears to be lofted aerosols over stratus at 07:26, with some indications that it was dust). Approximate time of first closest approach of the hurricane center was near 02:05 in Segment A (summary image attached).
